## Truss rafter roof support: How risk from inherent building defects is being exacerbated by changing climatic conditions

### Alan Holmes

The author's company was asked by a local council to survey a number of its properties, which were suffering a lean of the gable wall of bungalows. It was discovered that the gables were leaning due to roof trusses lying against the gable peak.

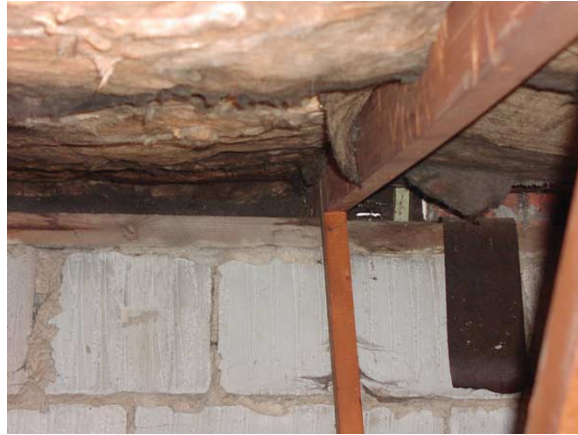
**Figure 1:** Truss leaning

The plumb survey revealed that the gable walls up to the peak were in general plumb. The peaks, however, had varying degrees of ‘leaning’, as illustrated in Figures 1 and 2. They varied from plumb to a 175mm outward lean.

1. Galvanised steel straps should be installed to tie the trusses to the gable and party walls.
2. Diagonal roof bracing should be installed to tie the roof trusses together.
3. Additional fixings should be installed to hold down the roof trusses to the front and rear.
4. Cracks in the ceilings should be cut out and filled using a proprietary filler.
5. External cracks in the brickwork should be cut back and re-pointed.

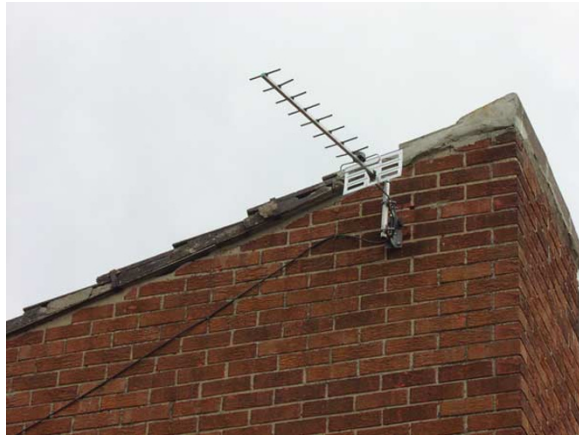
**Figure 3:** Damage at verge due to movement

The interlocking concrete tile roof cladding, in the main, had slid over the gable and party walls in the direction of the truss displacement (see Figure 3). In most cases it had slid over the peaks without causing damage.

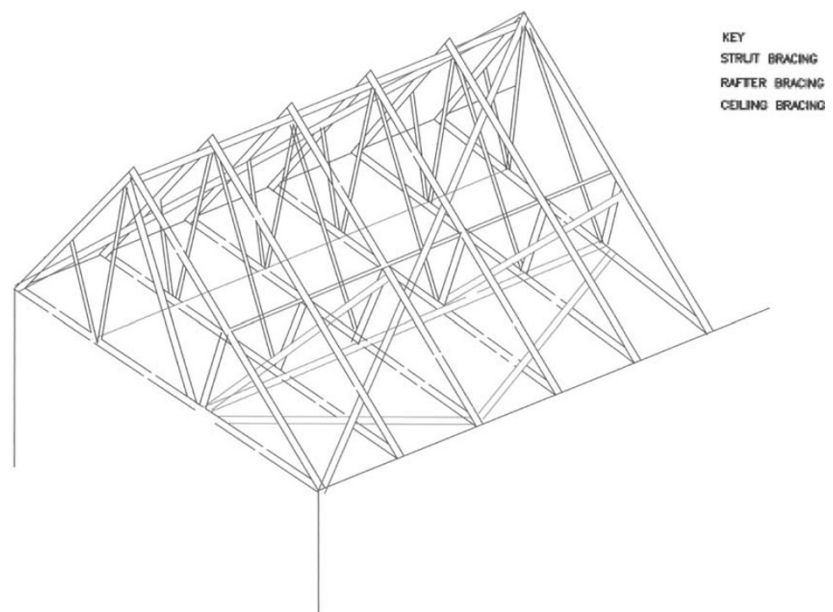
Figure 4: Modern roof construction

Roofs constructed in new houses nowadays are universally built with lightweight trussed rafters normally at 600mm (2-inch) centres. They are fabricated from 38mm thick timber members fastened together in one plane with metal connectors. The trussed rafters therefore provide support for the tiling battens and the ceilings without the necessity of providing separate ceiling joists, purlins or ridgeboard (see Figure 4).

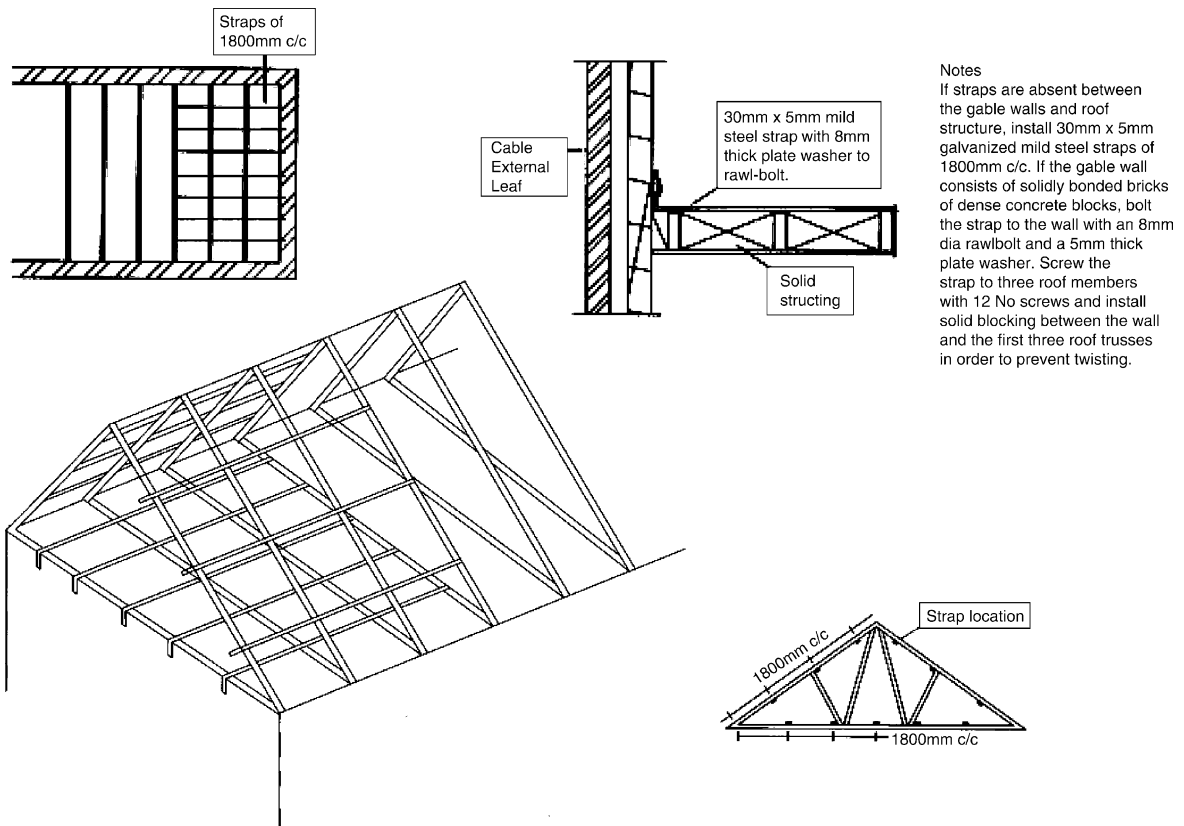
Figure 5: Roof construction showing positioning of lateral ties

The trusses are fabricated from high-grade timber under factory conditions using specialised equipment, while the design is based on the results of extensive research and testing. It should be emphasised that trussed rafters are engineered components and satisfactory performance can be ensured only by adopting correct erection procedures and fixing on site under competent supervision. Trussed rafters normally span between external load-bearing walls without the need for internal supporting walls, but adequate bracing of the whole roof and satisfactory connections to the supporting structure are essential to ensure overall stability (see Figure 5).
